West Manhood Drainage Improvement Group

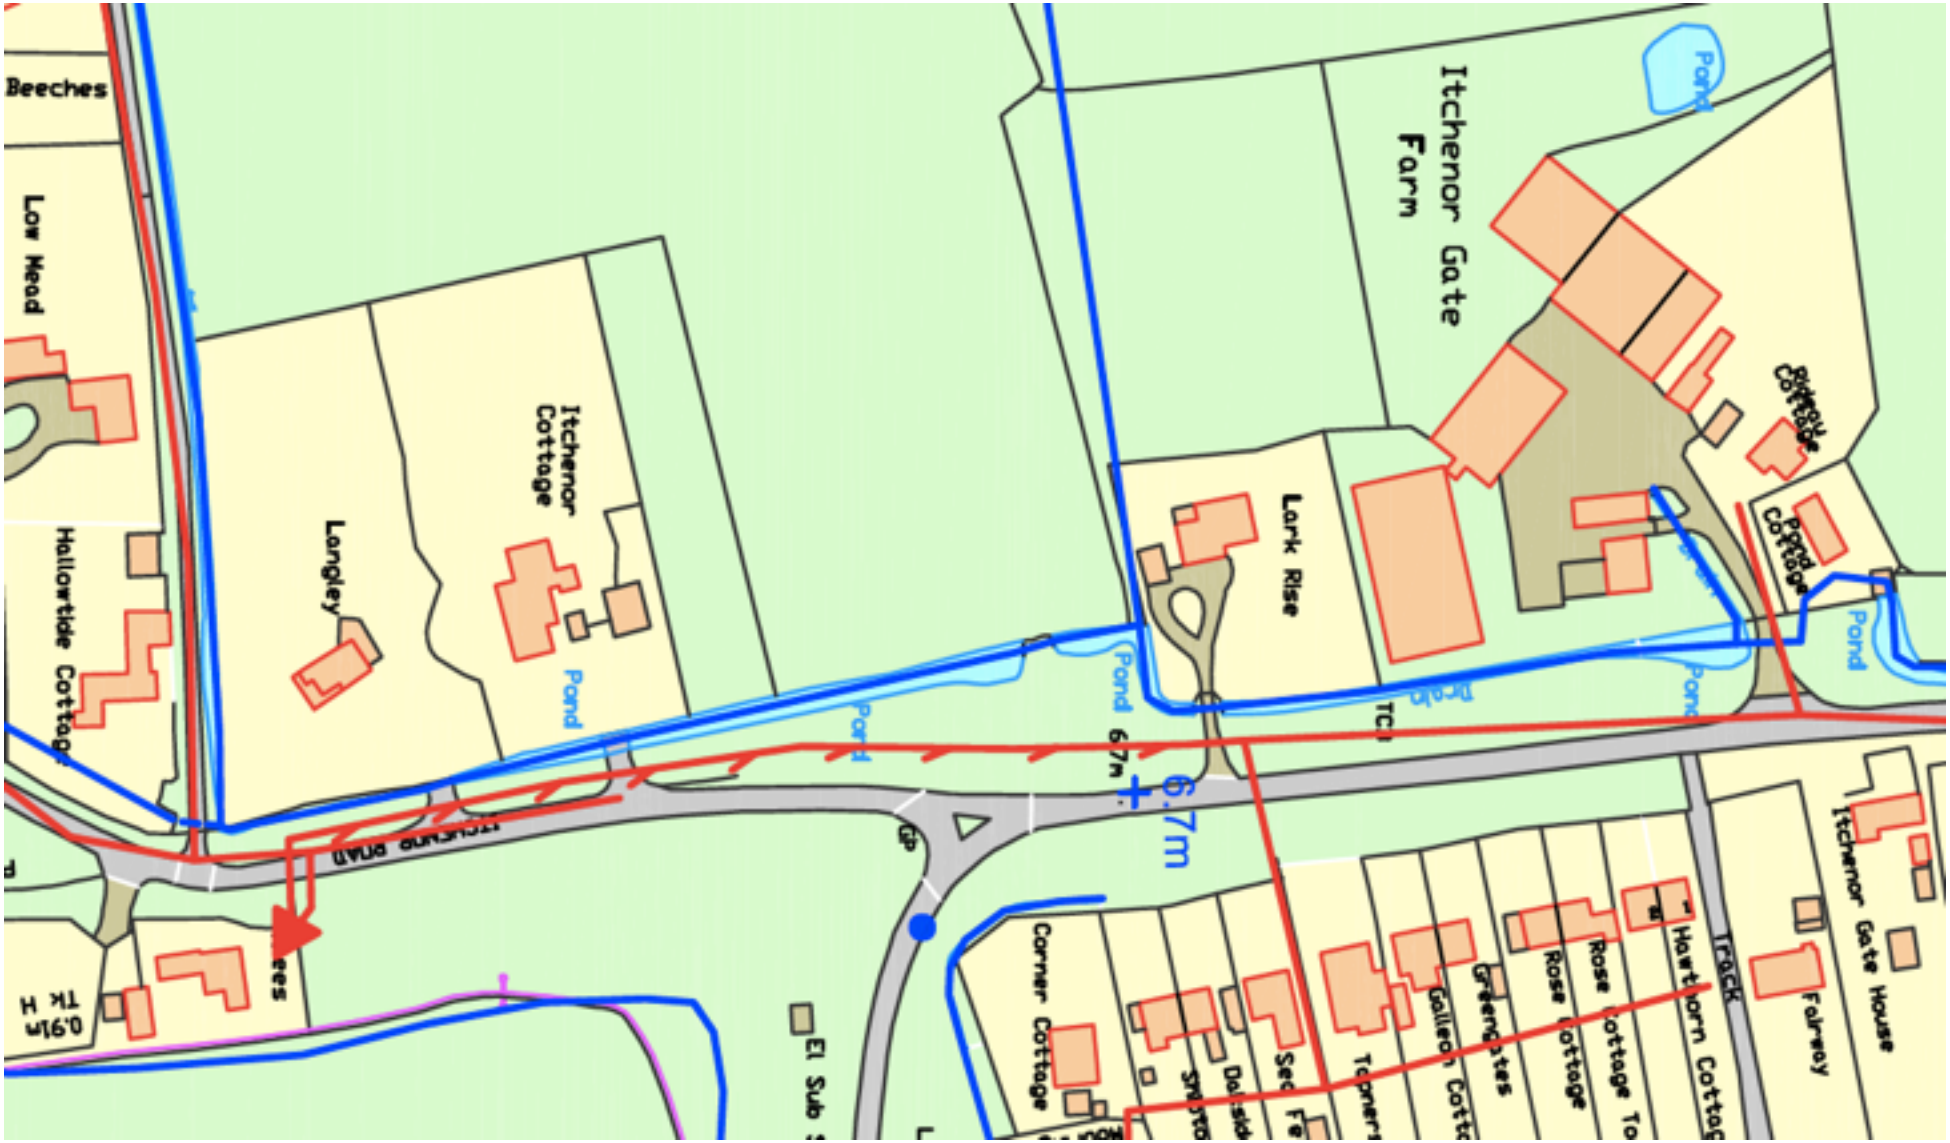
The Ditch network between itchenor Cottage and Pond Cottage is very large for storing water but largely overgrown. The planted trees provide screening but have not been managed and the field access has become a tipping area for grass. This is common Land and a pumped foul rising main passes nearby.

I have suggested that the screening to farm buildings should remain but that a clear track is made for an excavator and maintained in front of the ditch at Langley, Itchenor Cottage, the Ponds and Lark rise.
Would the PC resolve to do this.
